1983-1985 Honda VT-750C Shadow Tach Repair

**This page shows how to repair the two main issues with the '83-'85 VT750/700 tachs;
The infamous dead tach syndrome, and how to fix the lousy mount.**

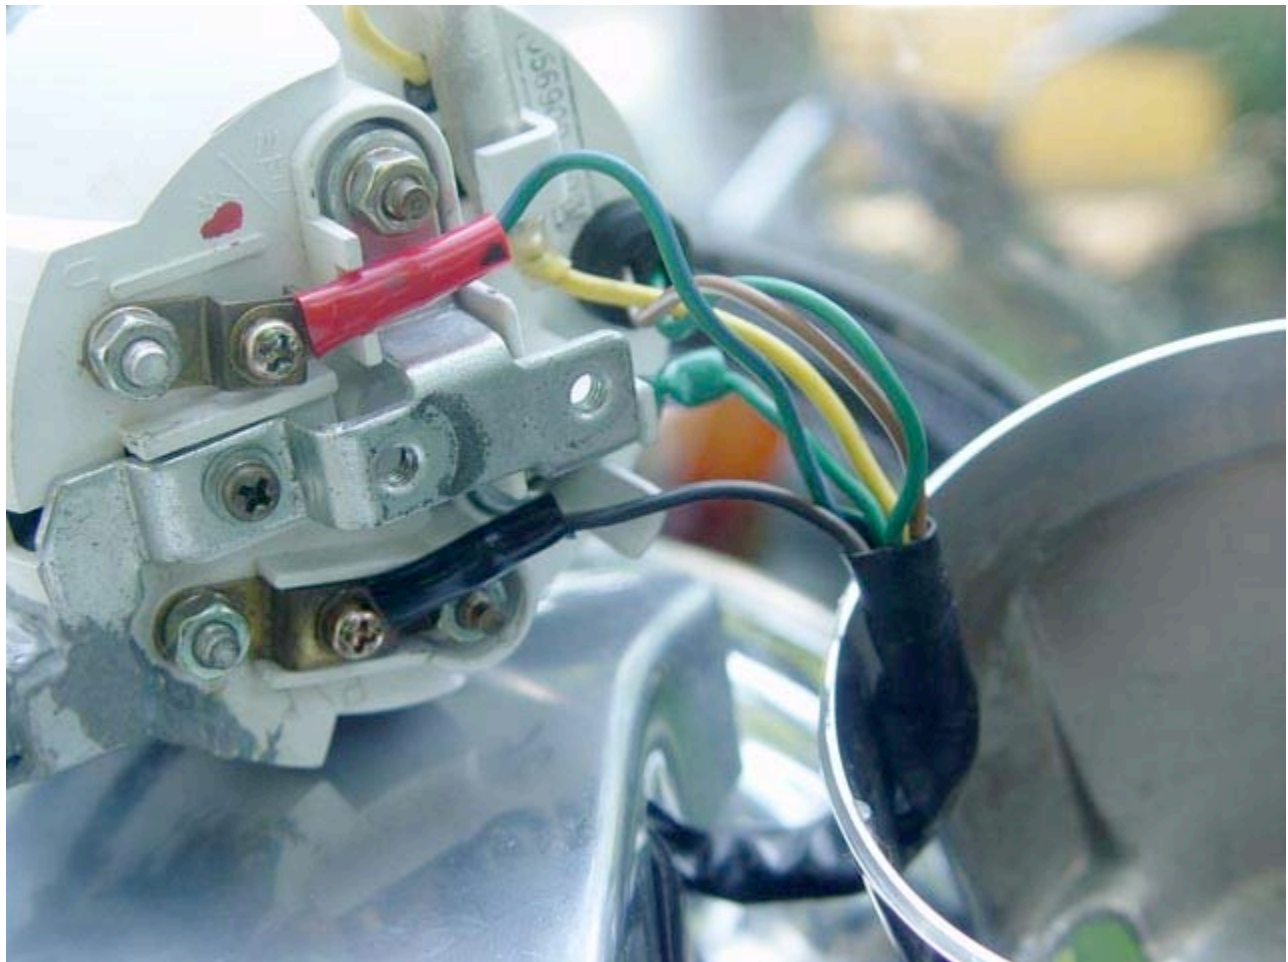
**When you get the mounting bolt and the two back screws off this is what you're looking at.
Note where the wires connect. I put a red dot on the case to help with re-assembly.
AND that the wires route through the back of the chrome case!!
(Remember that when you're putting it all back together....)**

These two images were taken during re-assembly after the repair was done.

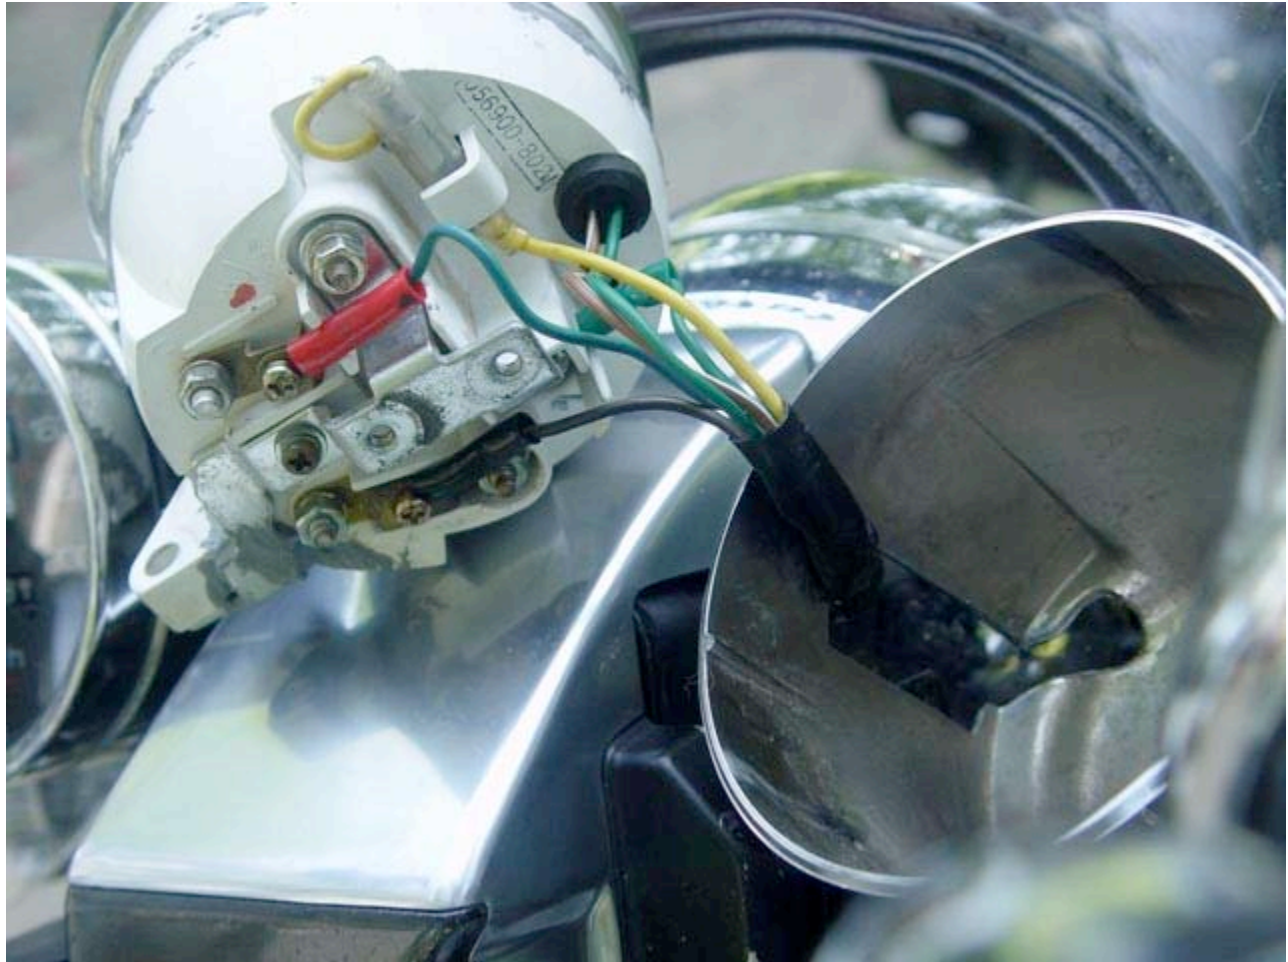
**When you cut the case open, don't worry about getting it perfectly straight around the case,
It actually works out a little better if the cut line isn't exactly perfect when it comes time to
re-glue the case. The 'offset' imperfections will help with re-aligning the two pieces....**

**Do try to get behind the thermometer dial, and there is a portion at the top where it is a little
thicker
where the light goes in.**

**The only thing to really watch for is to just 'barely' cut into the case. There are some wires in
there
that you don't really want to cut through, although if that does happen, they are easily repaired.**

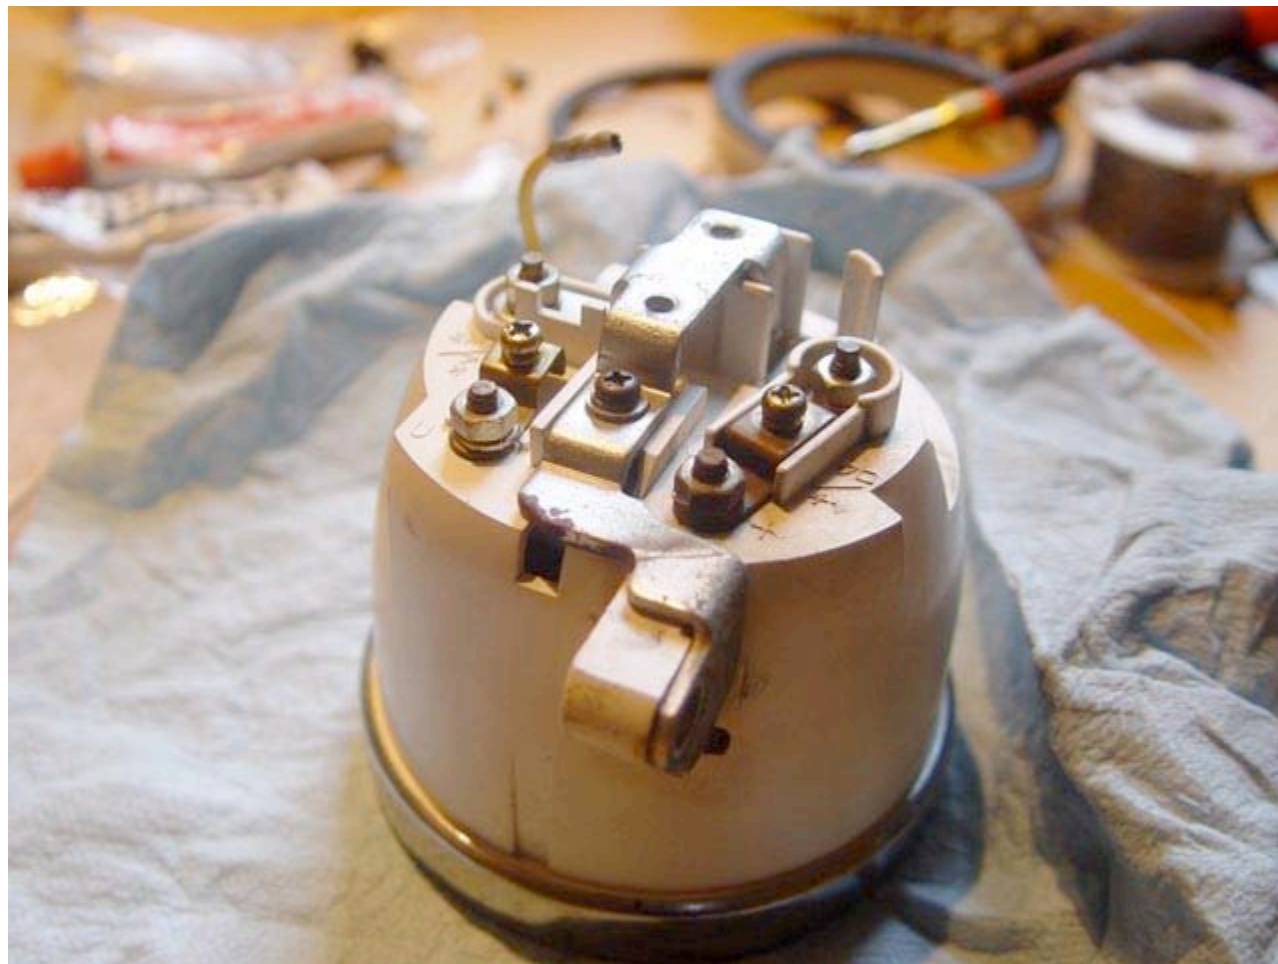
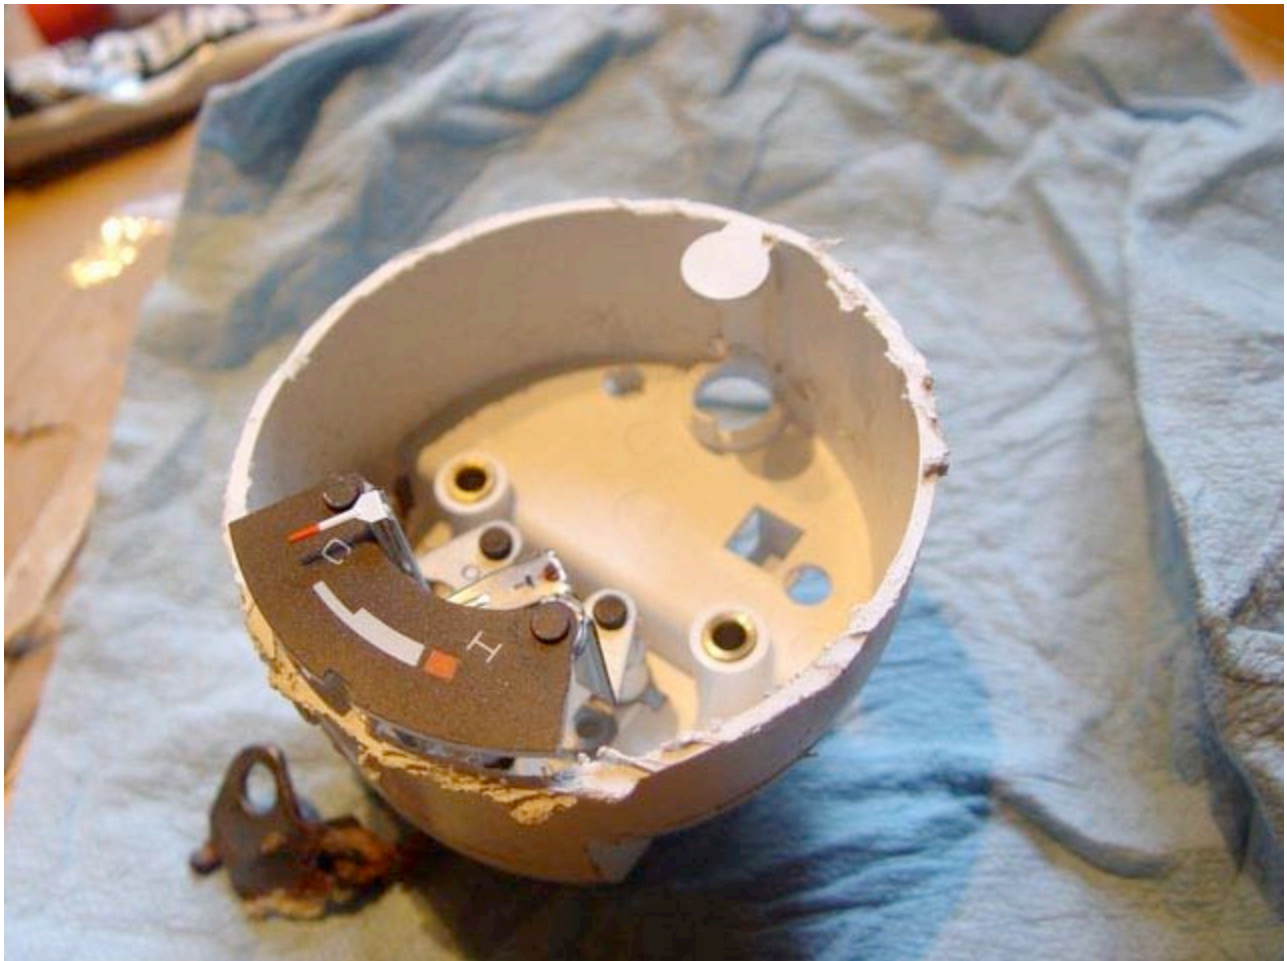
Cutting into the circuit board for the tach is not so easy....

The red and black wires can be unwound to further frmoce the circuit board, but it's not really necessary.

These are also the wires I referred to earlier that you 'may' cut through if you go to deap with the Dremel.

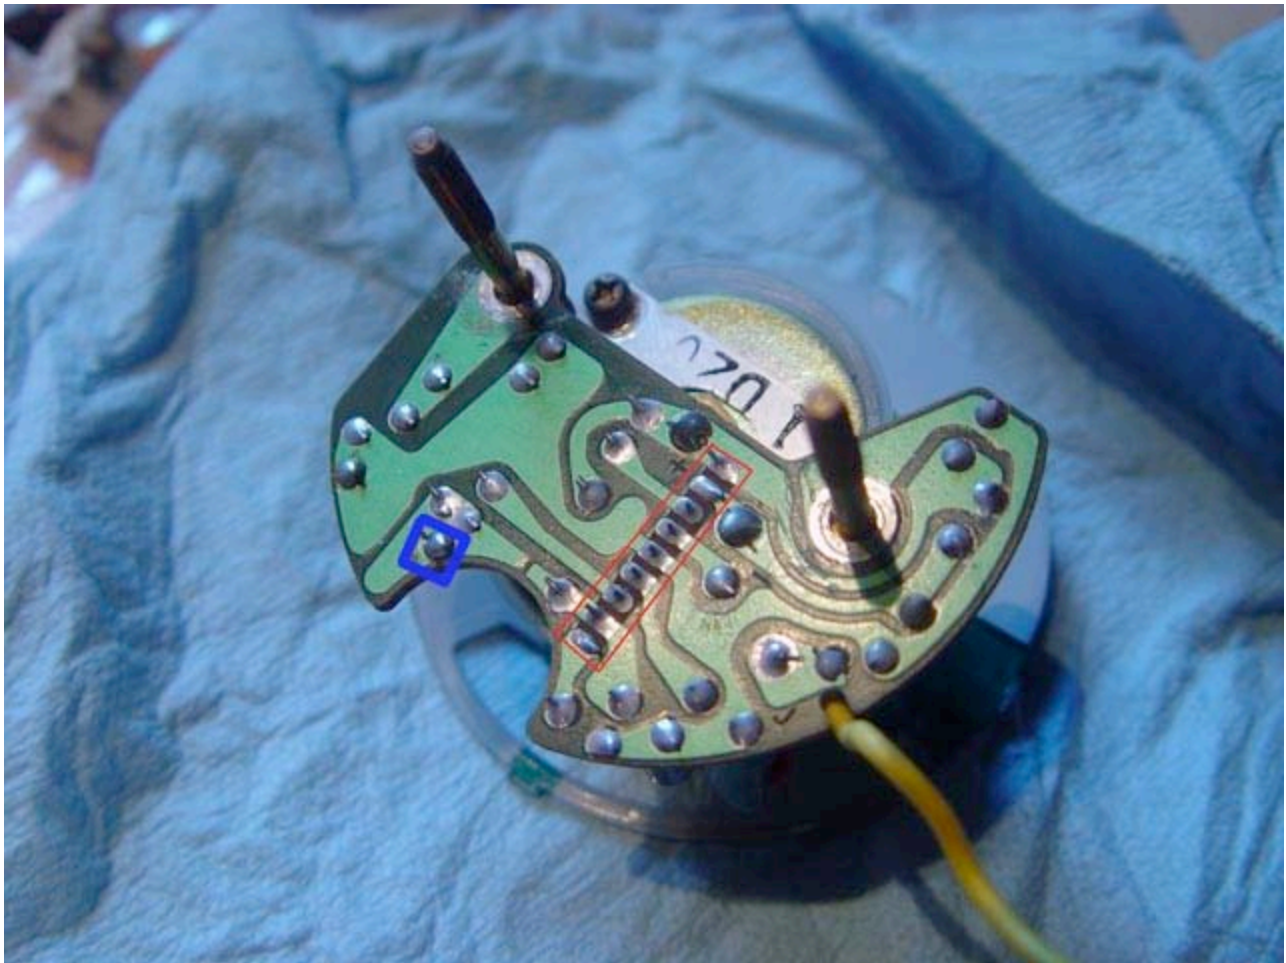
Note the red box and the blue box in the picture below.

The red box is the solder joints for the chip. They 'should' be ok but look vary closely at them. ALL other joints are suspect. Whatever process Honda used to solder the assembly together was pretty poor (like the blue box below).

I've done three of these repairs and found three different spots on each tha were the problem. I've since learned to hit ALL the solder joints other then those for the chip.

So, I do recommend reslodering ALL joints except the chip unless you see it is evident. Checking with a meter is also suspect, and some of these joints are just weak, not broken. Don't cheat yourself, hit them all with new solder....

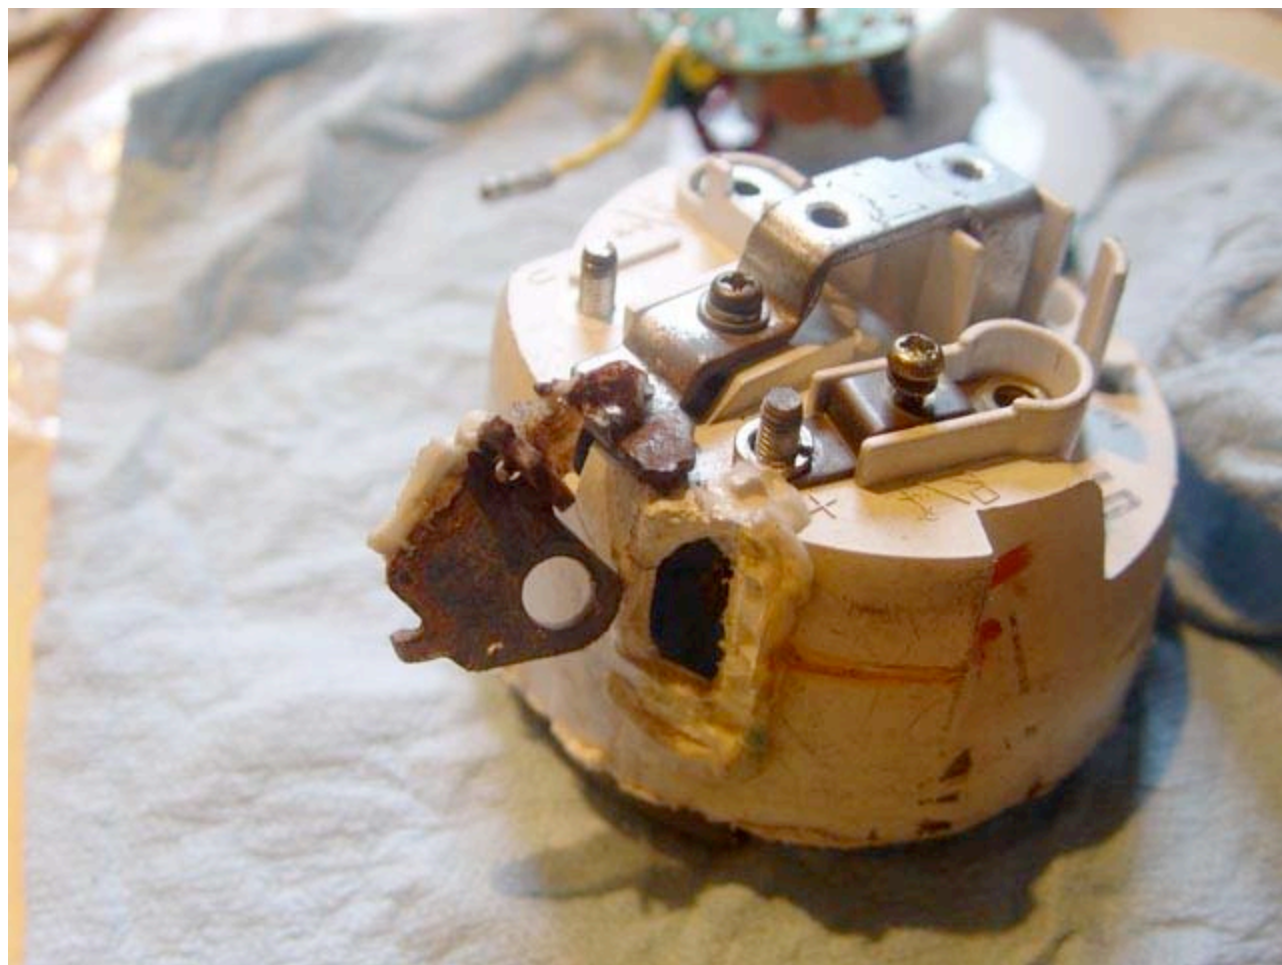
The poor mounts may end up looking like this:

At the point that the centre metal with the mounting holes makes the turn to go along the side of the case is a weak point. If yours is not broken yet, you may want to get pro-active and reinforce it with JB Weld while you have the case apart. The pictures below show JB Weld putting the case back together, and re-attaching the mount.

Leave the weld to cure for a day or so.

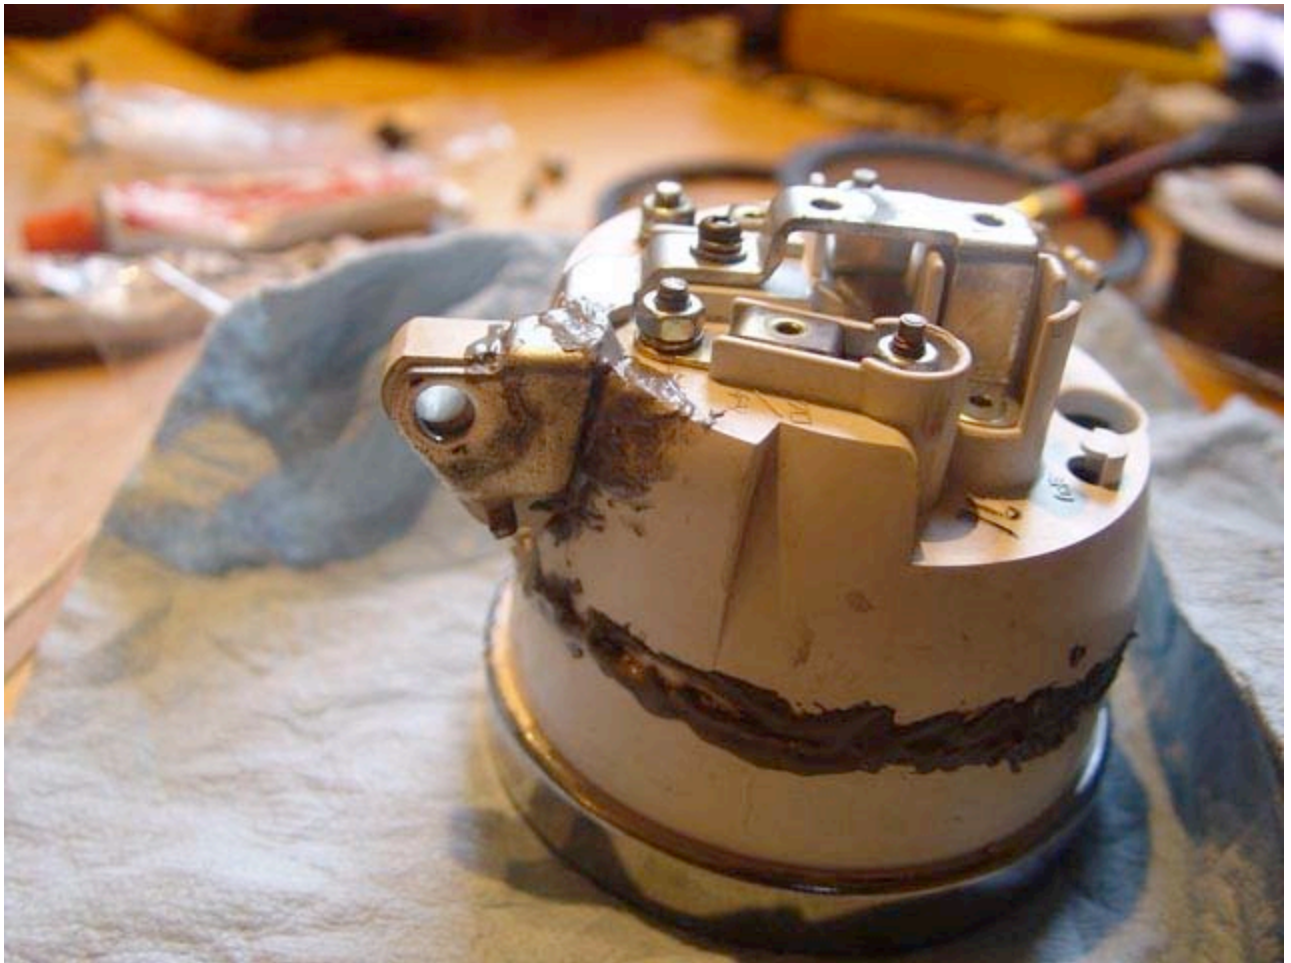
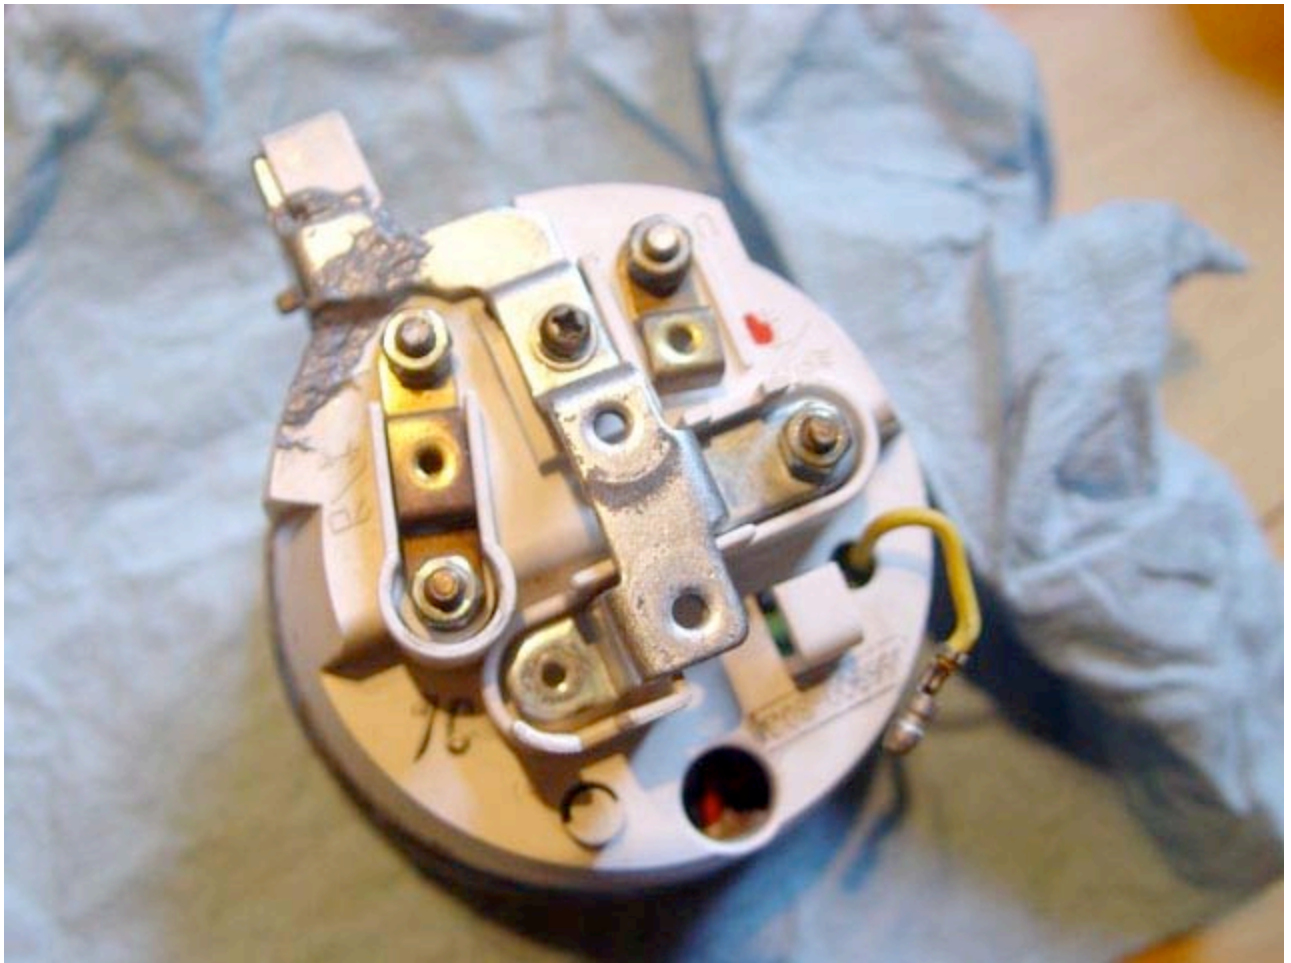
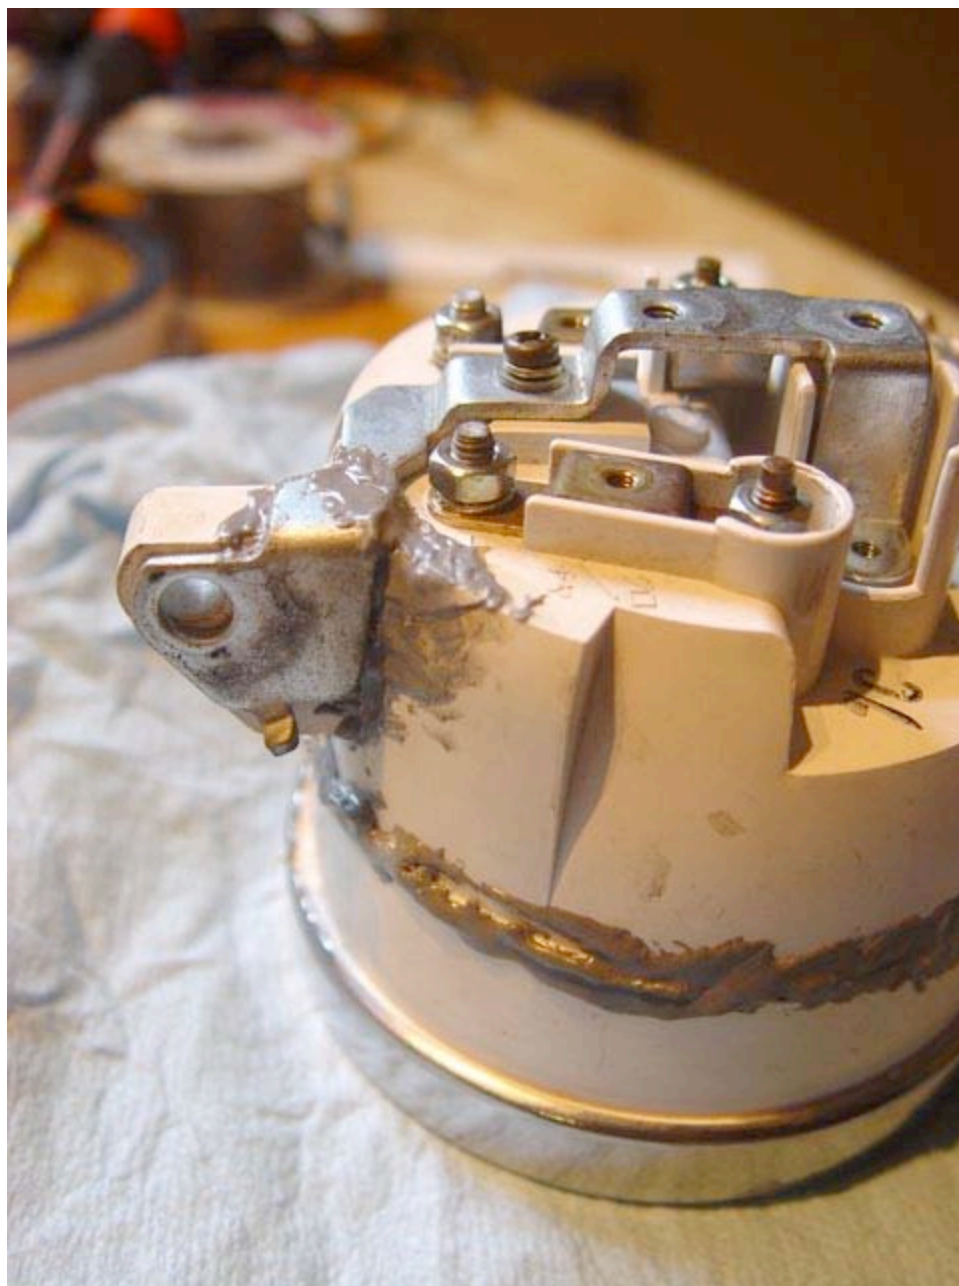
Note the small 'tab' to the below right of the tach mounting hole. That will line up with a small slot on the bike.

Do ensure that it is properly re-aligned before tightening the mount bolt otherwise it will put a LOT of stress on the plastic of the case....

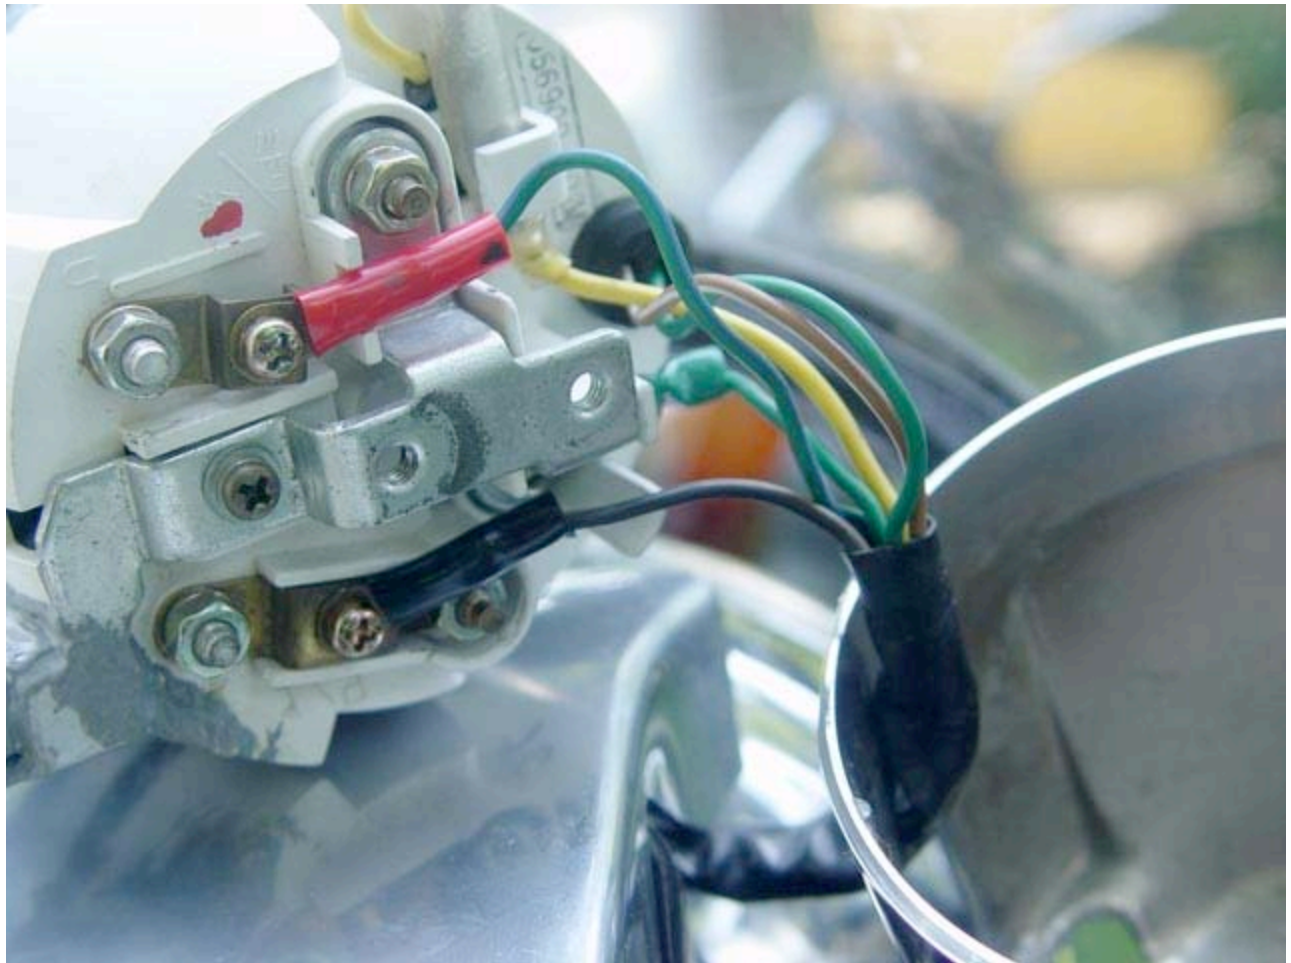
Do a quick reconnection and make sure it works before routing the wires back through the chrome case and remounting the tach.....

That's it. This should be a permanent repair.

I highly recommend the obvious:
